## Extreme Slow-Speed Bearing Condition Monitoring with Ultrasound

Take the following case for example; a slow-speed wastewater decanter at a Pulp & Paper Processing Plant.

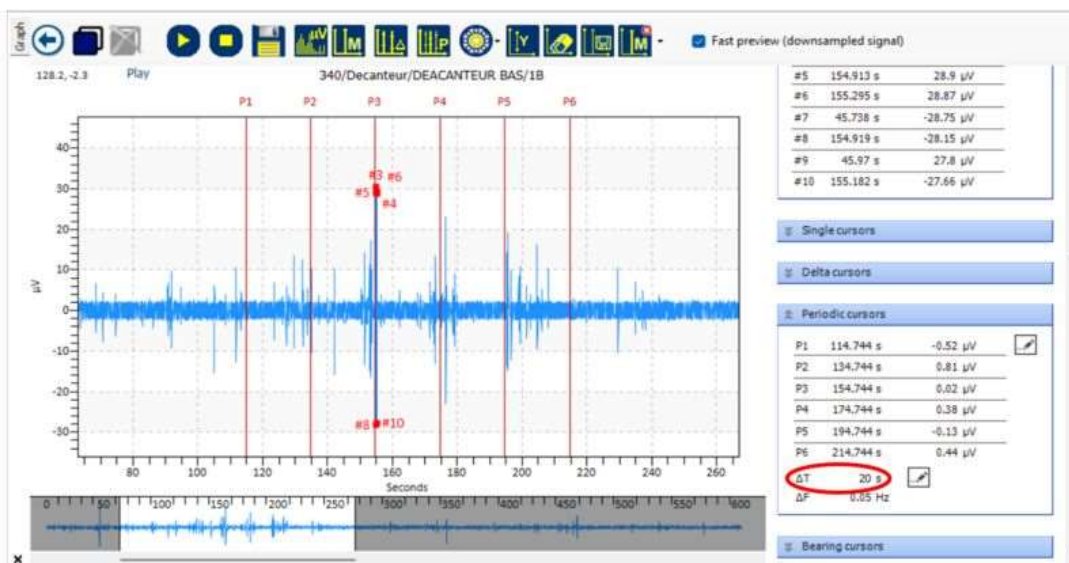
Figure 1: Time Wave Form Recorded using the SDT340, Analyzed in UAS3

Based on the data in the Time Wave Form (Figure 1), and the FFT (Figure 3) below, we suspect there is a broken tooth on this slow-speed assets pinion.

Cracked and broken teeth generate high levels of ultrasound at 1 x RPM in the time waveform. Figure 2 depicts what a typical time waveform looks like when dealing with a cracked or broken tooth.

Observed in Figure 1, we can see a similar pattern to that in Figure 2. There is a pronounced spike every time the problem tooth tries to mesh with the teeth of the bull gear. The time between impacts corresponds to 1/RPM of the gear with the tooth problem.

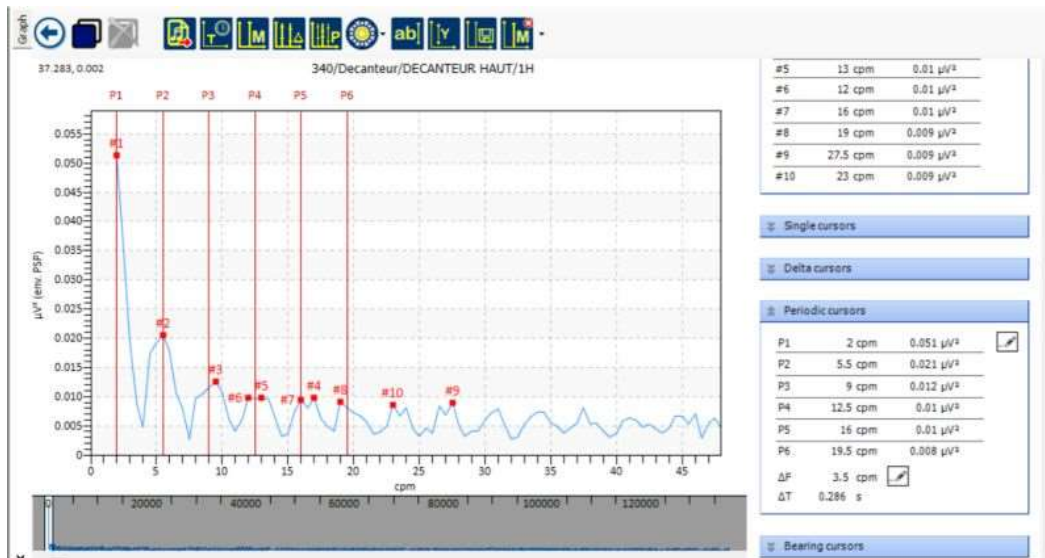
Figure 3: FFT Recorded with SDT340 and Analyzed using UAS3

As observed in the pinion's FFT (Figure 3), it can be seen that high levels of ultrasound above the sound floor are appearing at 1 X RPM indicating a broken tooth on the pinion.

SDT's Partnered Ultrasound Team was able to accurately diagnose that there was a broken tooth on the 2.95rpm pinion using ultrasound condition monitoring.
