## Extreme Slow-Speed Bearing Condition Monitoring with Ultrasound

Take the following case for example; a slow-speed wastewater decanter at a Pulp & Paper Processing Plant.

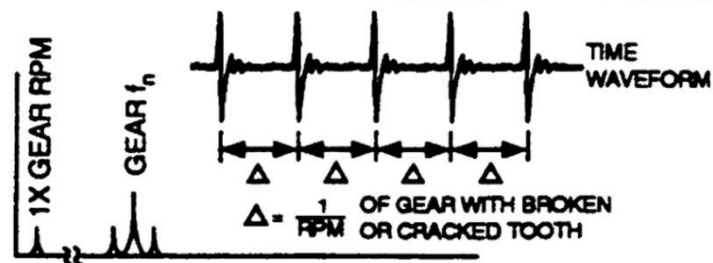
Figure 2: Vibration Analysis Textbook – 1/RPM of Gear with Broken or Cracked Tooth

Cracked and broken teeth generate high levels of ultrasound at 1 x RPM in the time waveform. Figure 2 depicts what a typical time waveform looks like when dealing with a cracked or broken tooth.

Observed in Figure 1, we can see a similar pattern to that in Figure 2. There is a pronounced spike every time the problem tooth tries to mesh with the teeth of the bull gear. The time between impacts corresponds to 1/RPM of the gear with the tooth problem.
