# SONAVU+

# THE **NEXT GENERATION** OF **ACOUSTIC IMAGING**

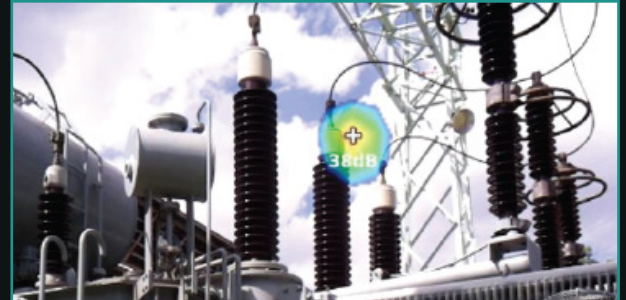
## ELECTRICAL SYSTEM RELIABILITY

Issues like arcing, tracking, and corona discharge generate high-frequency sound, often undetectable by the human ear. Acoustic imaging inspection makes these faults visible, allowing maintenance teams to pinpoint and address them before they escalate.

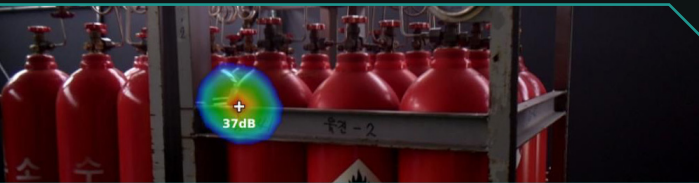
## LEAK DETECTION

Acoustic imaging makes locating and visualizing leaks in real time easy... Even in noisy environments. When leaks are identified promptly, energy costs go down, system efficiency goes up, and compressed lifespan is extended.

Fugitive emissions threaten safety and compliance. But locating them is challenging due to low pressures and hazardous environments. SonaVu+ delivers sensitivity, range, and ATEX availability for safe, reliable inspections.

Vacuum leaks create system inefficiencies, energy waste, and can potentially damage products and equipment. Acoustic imaging is a fast and reliable way to locate these leaks by visualizing the high frequency sounds they produce.

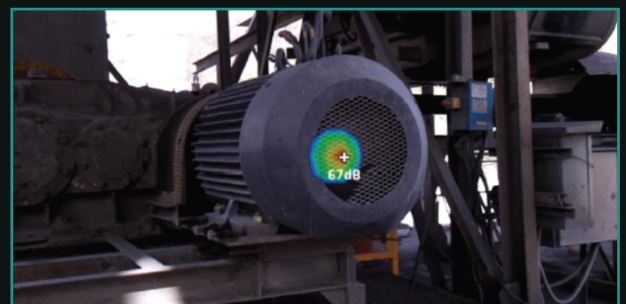
## MECHANICAL

Acoustic imaging inspection is a powerful tool for monitoring critical drivetrain components such as couplings, conveyors, belts, chains, and drives. These assets often operate under heavy loads and are prone to wear, misalignment, and lubrication issues, which generate high-frequency sound as friction and impact increase.
