SONAVU+

THE **NEXT GENERATION** OF **ACOUSTIC IMAGING**

SONAVU+ BRINGS NEW FUNCTIONALITY TO ACOUSTIC IMAGING

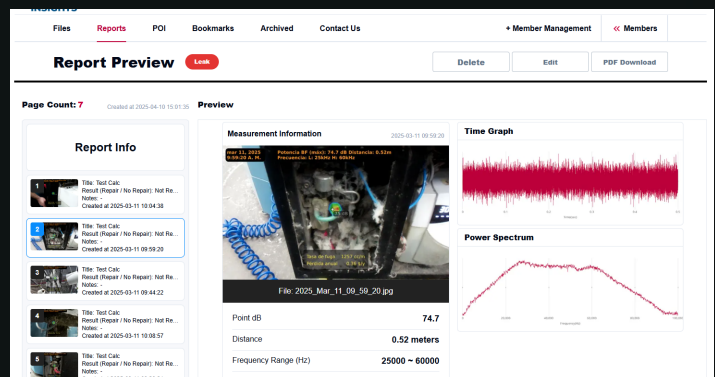
SonaVu InSights™ Reporting Application

The SonaVu InSights™ app transforms every inspection into a professional and actionable report. Every finding is documented with images and video, giving teams a clear visual record of leaks, discharges, or anomalies.

Defects are automatically ranked by severity and impact, while energy losses or downtime risks are calculated to prove ROI. All results are stored in one cloud-based hub, making them easy to access, organize, and track over time.

Reports can be shared across maintenance, reliability, and management teams with a click, ensuring alignment and driving action across the organization.
